Appendix D

Charts of Plotted Data from Tensiometers with Performance Evaluation and Recommendations

D1. KEY TO APPENDIX

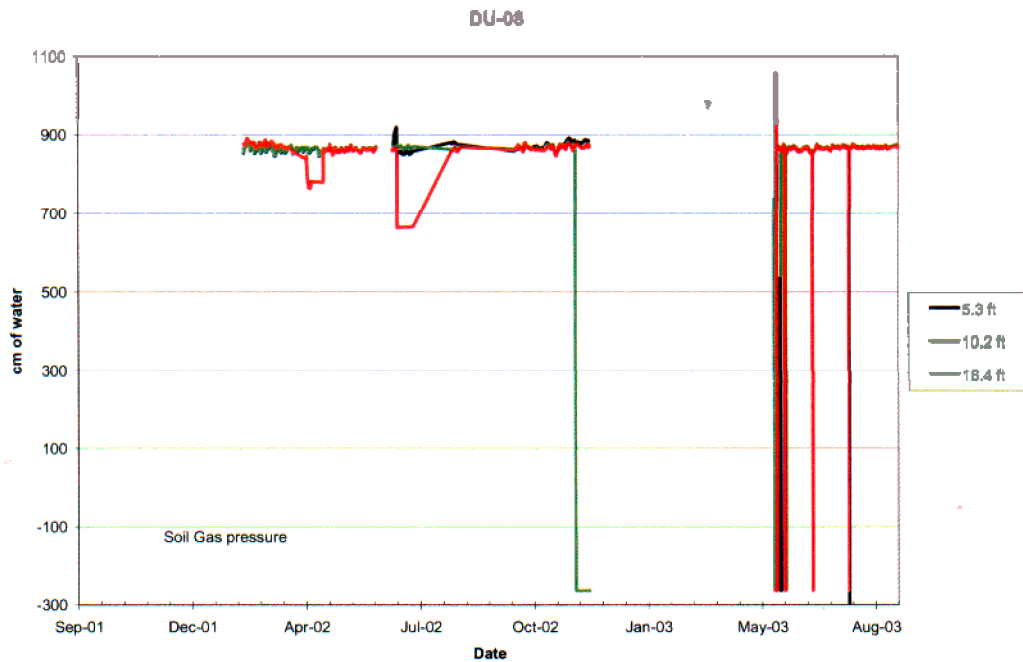
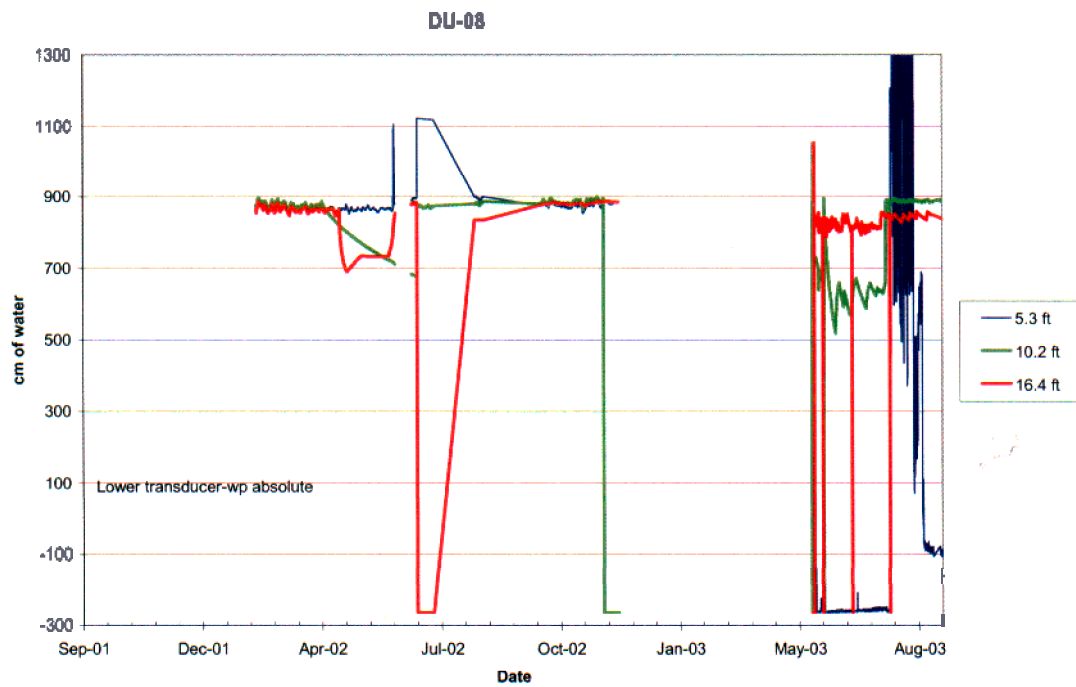
Figure D-1. Cluster DU-08.

T1, 5.3 ft: Soil gas pressure not working, absolute wp transducer not operating, spool valve not operating.
T2, 10.2 ft: Soil gas pressure working, absolute wp transducer works sporadically.
T3, 16.4 ft: Soil gas pressure working, absolute wp transducer has not responded to refilling.

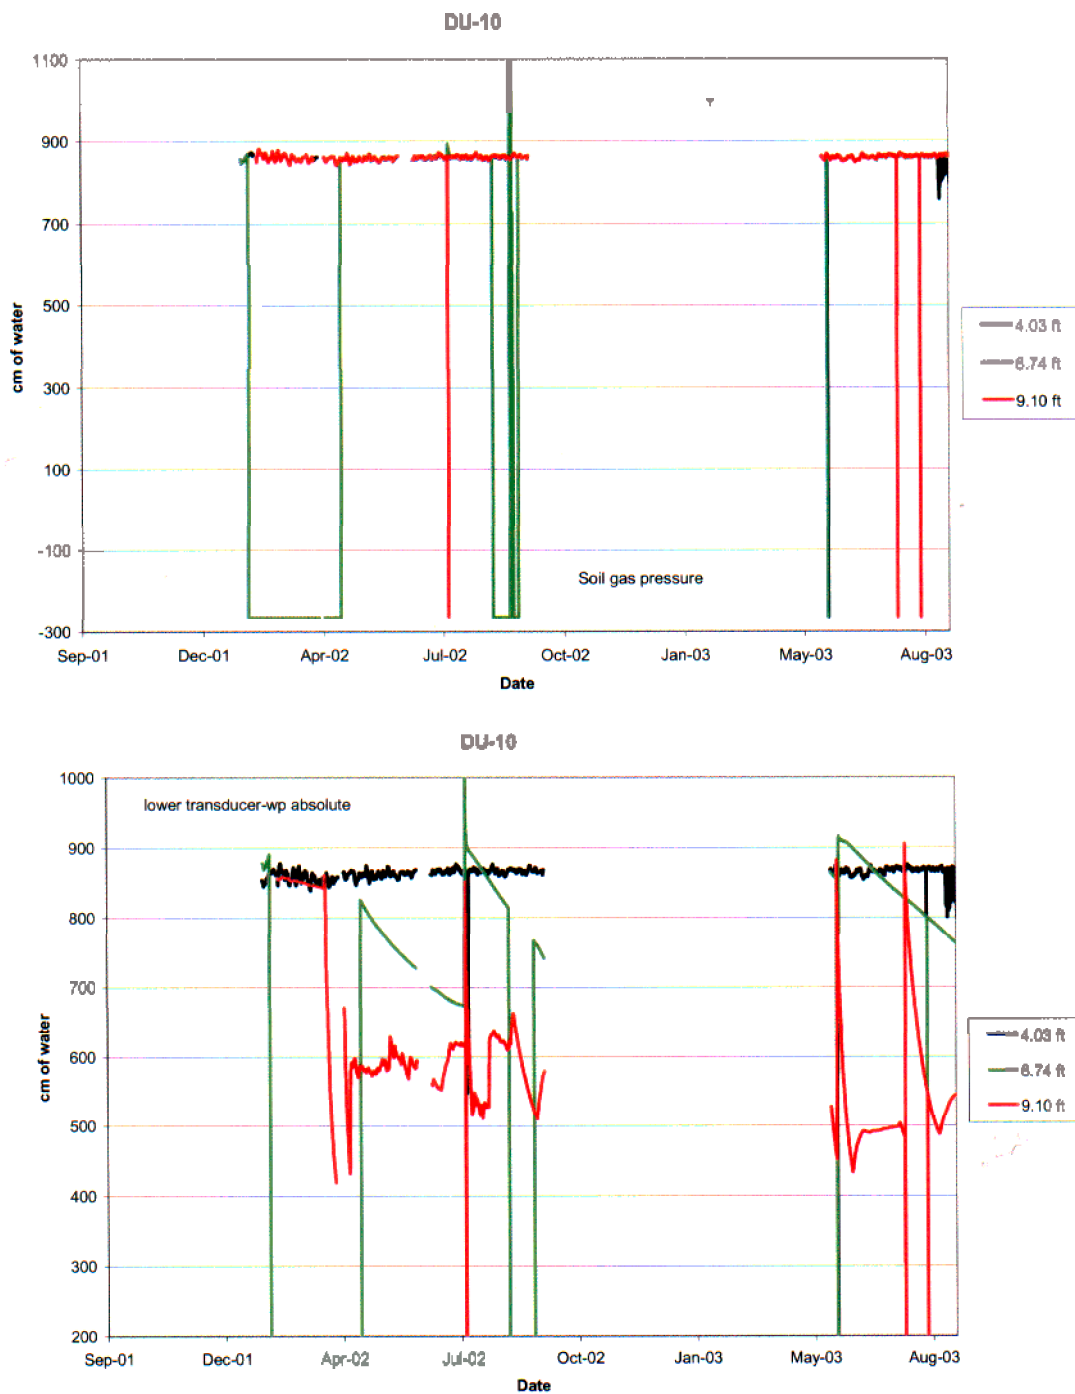
Figure D-2. Cluster DU-10.

T1, 4 ft: Soil gas pressure working, absolute wp transducer has not worked.
 T2, 6.7 ft: Soil gas pressure working, absolute wp transducer has responded to refilling.
 T3, 9.1 ft: Soil gas pressure working, absolute wp transducer data are variable, but sensor appears to be working in September 2003.

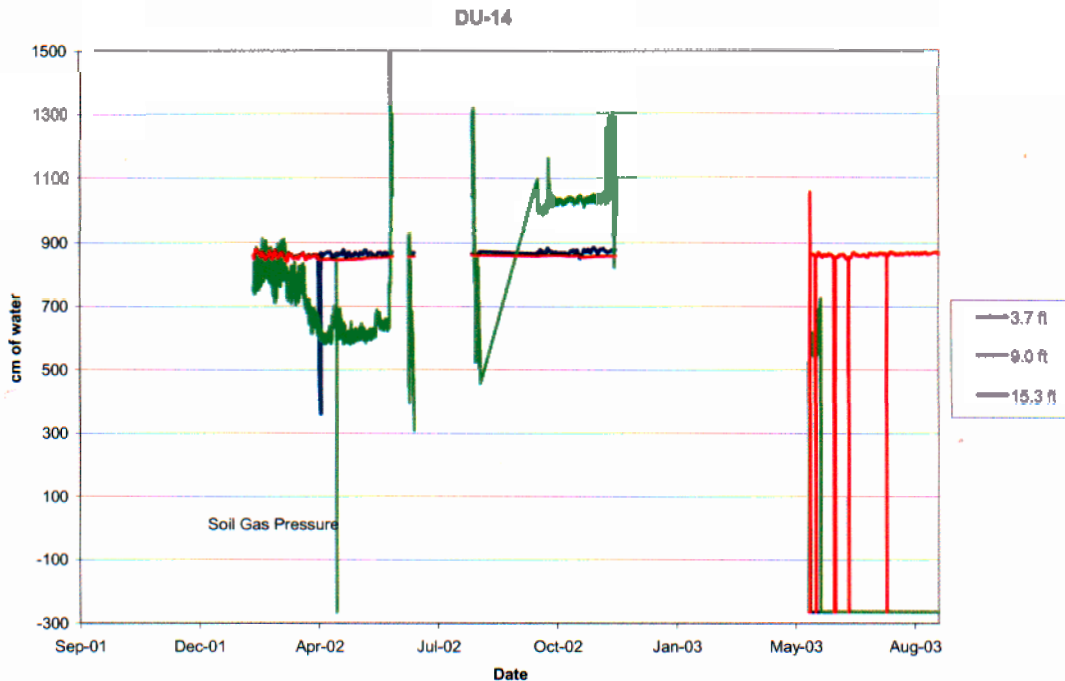
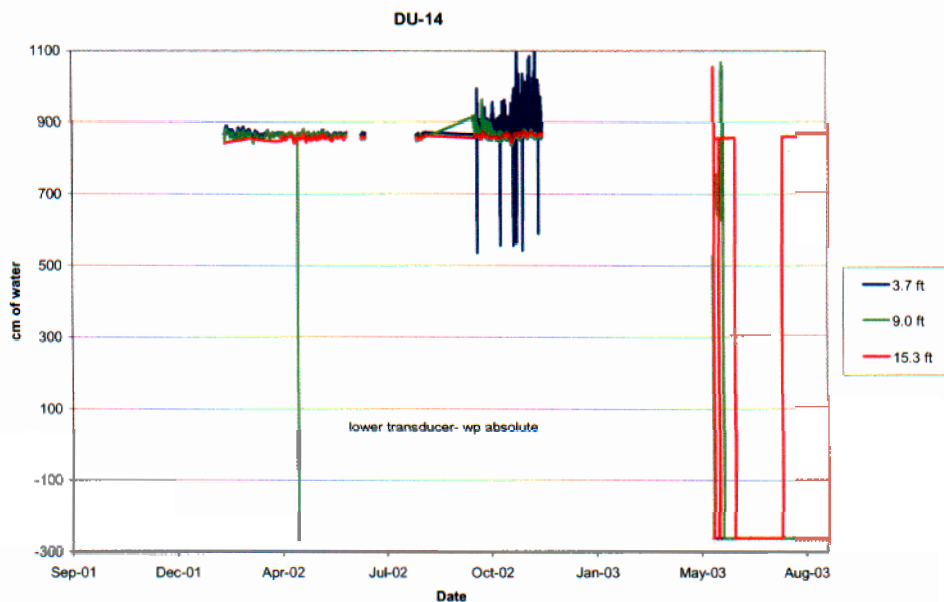
Figure D-3. Cluster DU-14.

T1, 3.7 ft: Soil gas pressure and absolute wp transducer not working (-273).

T2, 9 ft: oil gas pressure not working, absolute wp transducer shows loss of signal, also no response to refilling, could not field calibrate.

T3, 15.3 ft: Soil gas pressure does not appear to be working (data are flat in fall 2003), transducer not able to yield good data because spool valve is not working, cannot fill with water.

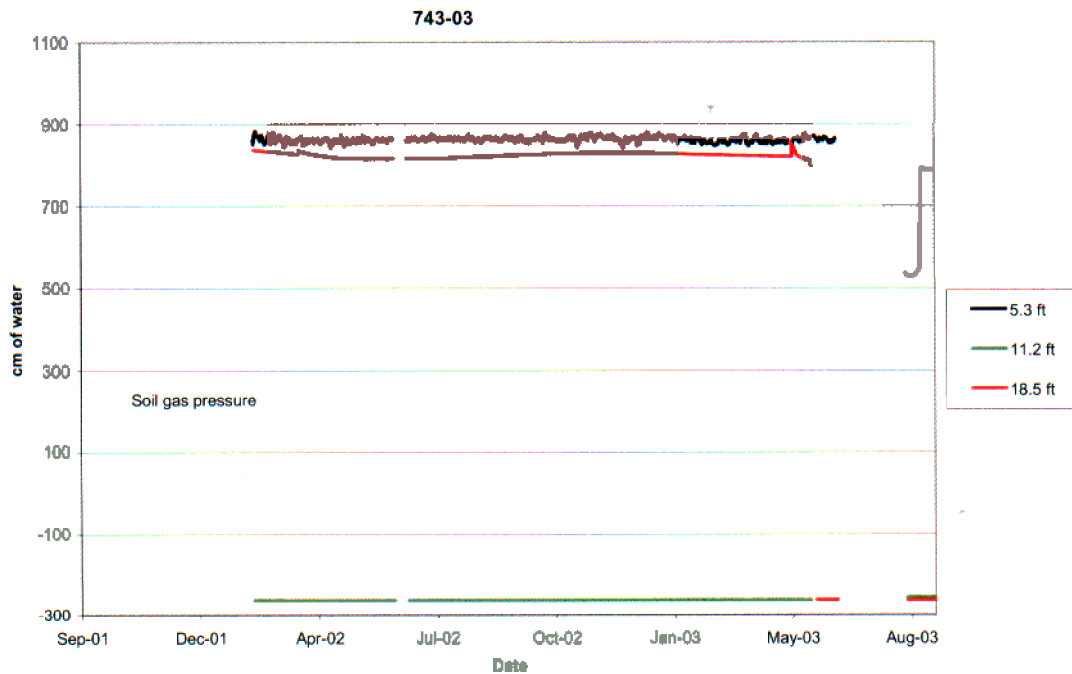
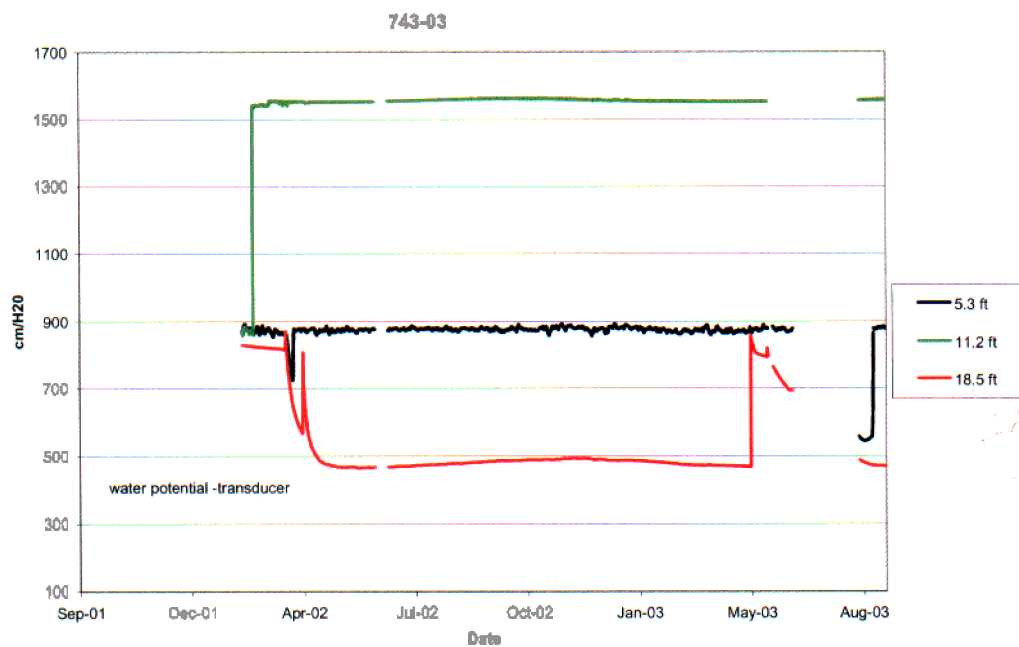
Figure D-4. 743-03.

T1, 5.3 ft: Soil gas pressure not currently working, [redacted] has responded to refilling with water in the past. Soil gas pressure and wp wires may be reversed.

T2, 11.2 ft: Soil gas pressure not working (-273), [redacted] absolute wp transducer not working, out of range.

T3, 18.5 ft: [redacted] appears isolated from atmosphere in early measurements, not giving a signal in later measurements. [redacted] absolute wp transducer working.

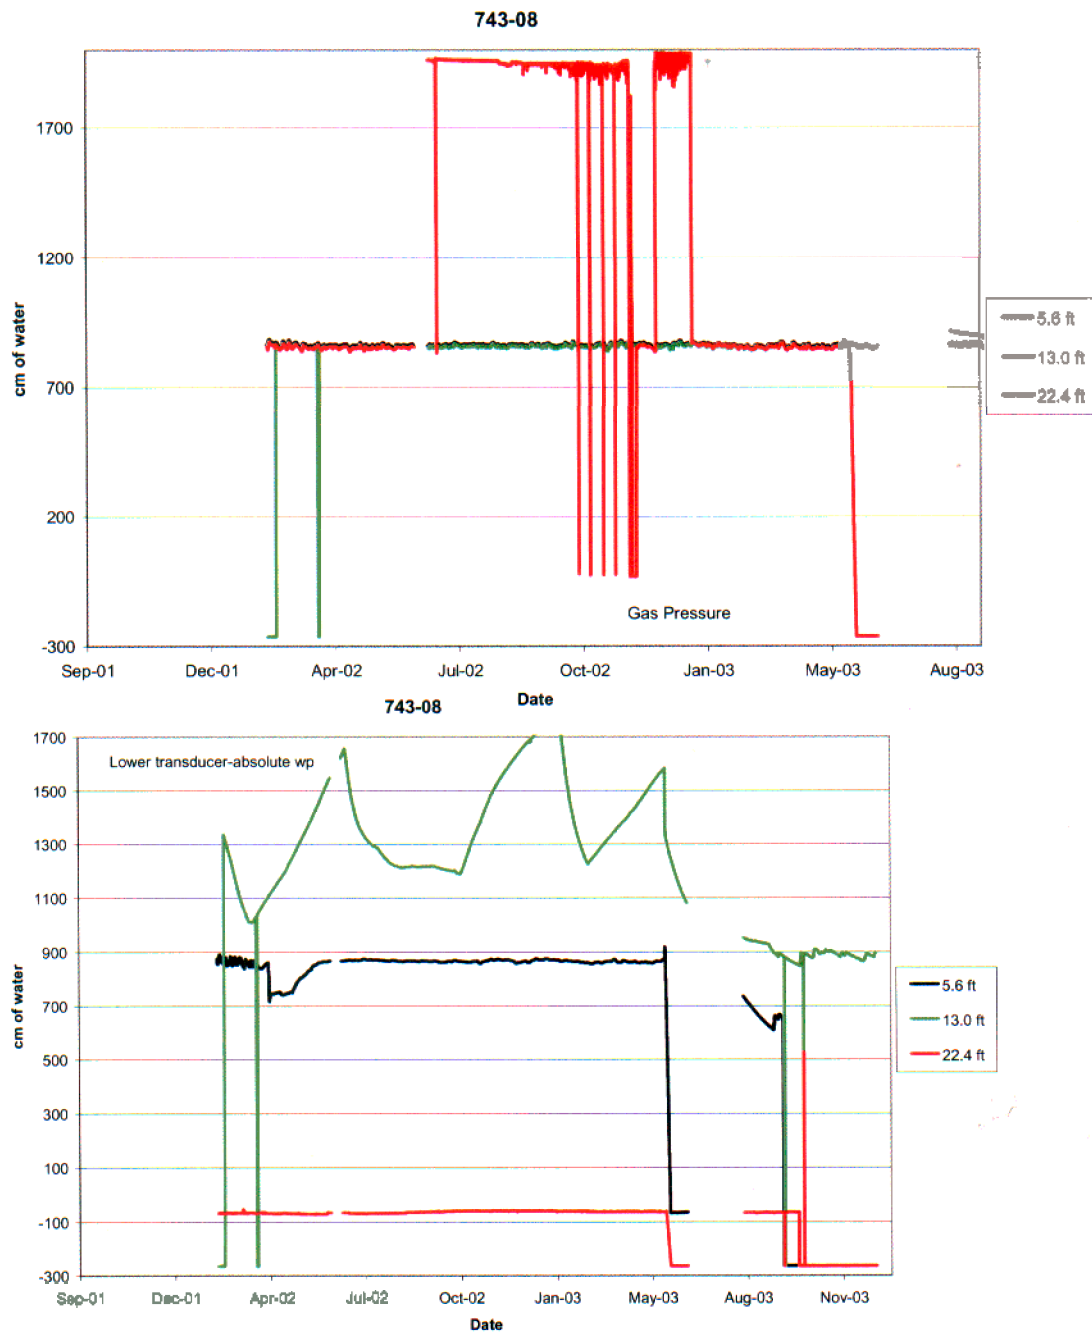
Figure D-5. 743-08.

T1, 5.6 ft: Soil gas pressure working, absolute wp transducer may be working.
 T2, 13 ft: Soil gas pressure working, absolute wp transducer beginning to track barometric pressure, try refilling.
 T3, 22.4 ft: Soil gas pressure working, absolute wp transducer has never responded, wires are pulled loose.

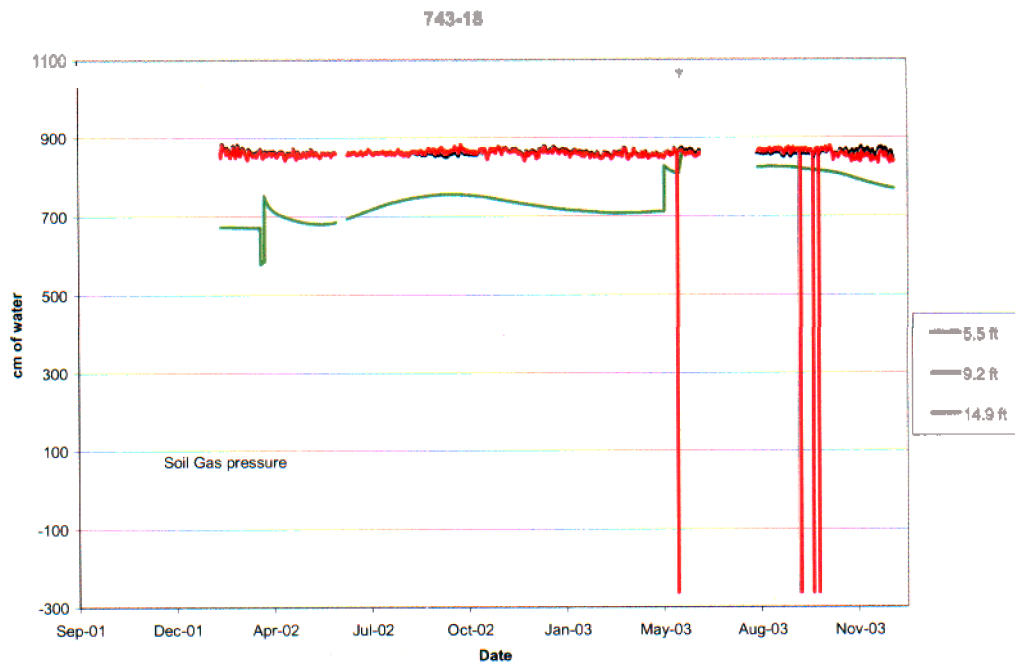
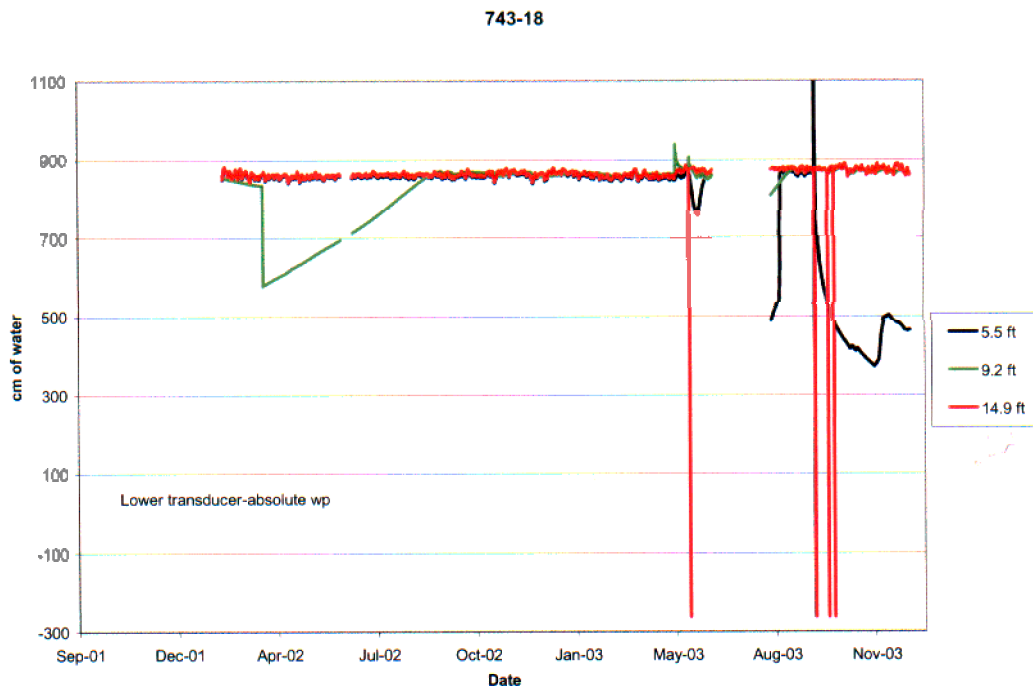
Figure D-6. 743-18.

T1, 5.5 ft: Soil gas pressure working, absolute wp transducer responded to refilling,
 T3, 9.2 ft: Soil gas pressure appears to be isolated from atmosphere, absolute wp transducer not
 responding.
 T2, 14.9 ft: Soil gas pressure working, discontinued absolute wp transducer, spool valve stuck open.

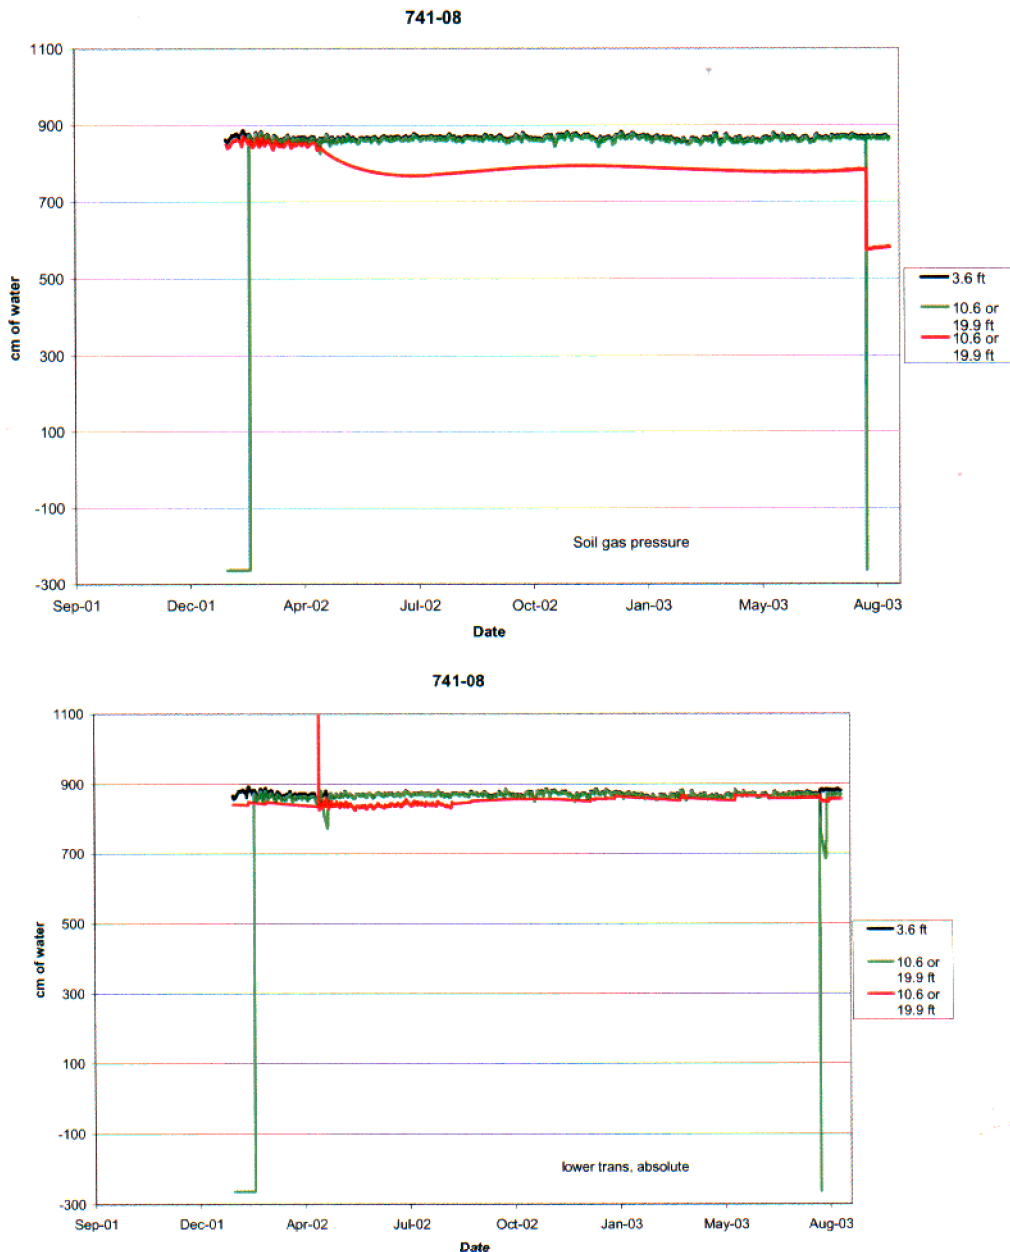
Figure D-7. 741-08.

T1, 3.6 ft: [redacted] working, [redacted] not working.

Note: Wires between the 10.6- and 19.9-ft depths were switched in September 2003, and the switch needs to be double-checked in the field. Therefore, the following two tensiometers are not referred to by depth.

Green line: [redacted] works, [redacted] absolute wp transducer shows response to refilling.

Red line: Wires for soil gas pressure and absolute wp transducer may be switched. If wires are switched, (lower figure) works, but [redacted] absolute wp transducer (upper figure) worked until fall 2003, needs troubleshooting.

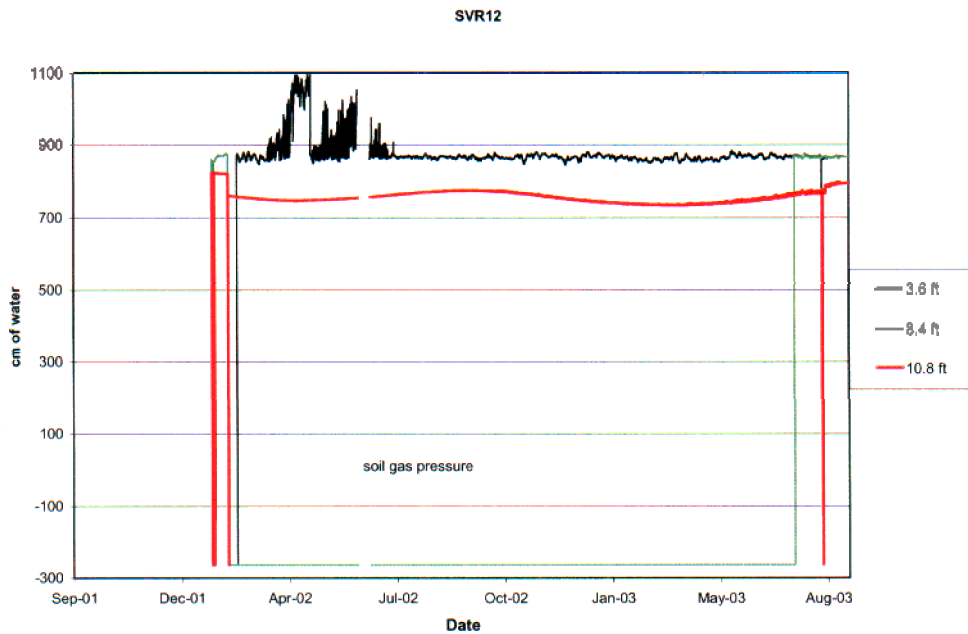
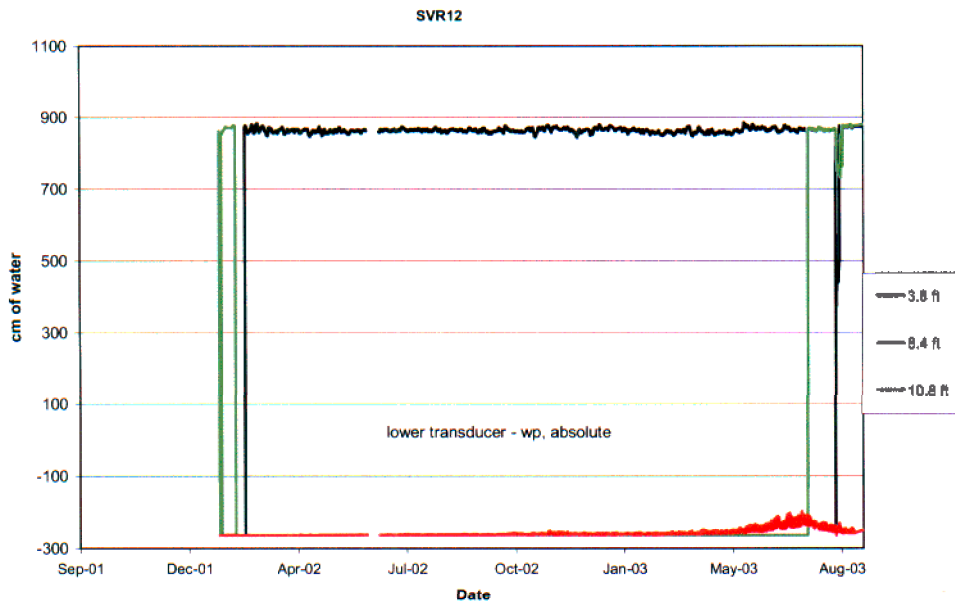
Figure D-8. SVR-12.

T1, 3.6 ft: Soil gas pressure works, [redacted] has not responded to refilling.
T2, 8.4 ft: Soil gas pressure currently working after not working for over 1 year, absolute wp transducer appears to respond to refilling.
T3, 10.8 ft: Soil gas pressure appears to be isolated from atmosphere, absolute wp transducer is not operable (field checked).

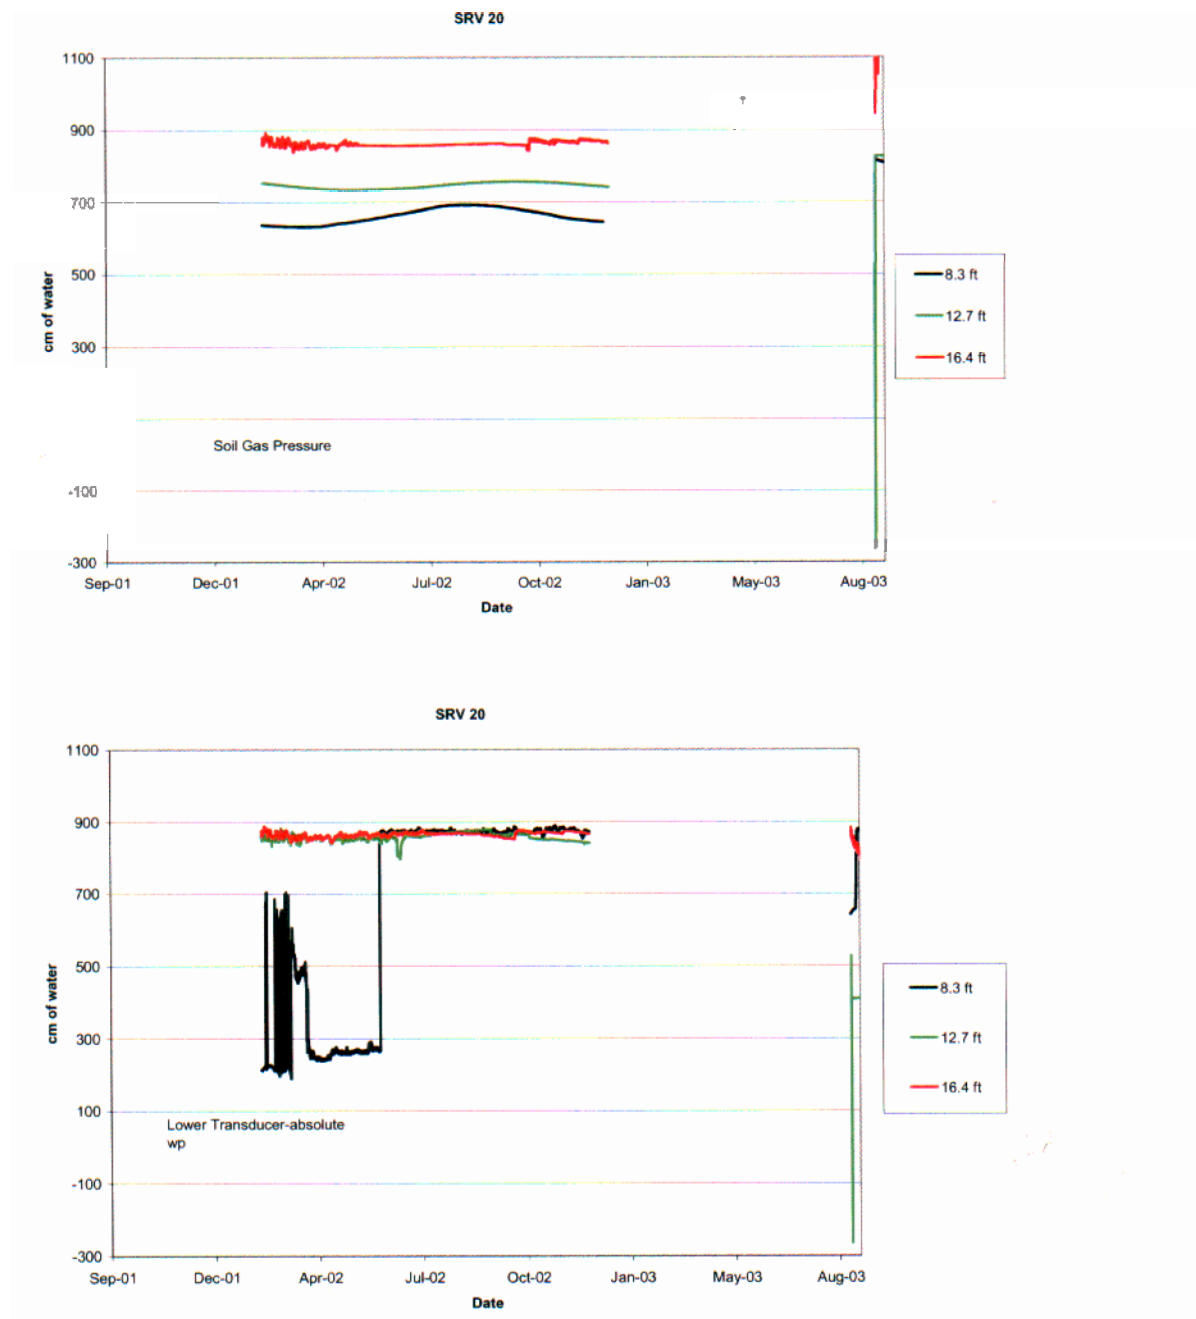
Figure D-9. SVR-20.

T1, 8.3 ft: [REDACTED] appears to be isolated from atmospheric pressure, [REDACTED] has responded in the past.

T2, 12.7 ft: [REDACTED] appears to be isolated from atmospheric pressure, absolute wp transducer appears to be working.

T3, 16.4 ft: Soil gas pressure working, isolated from atmospheric pressure, [REDACTED] is working.

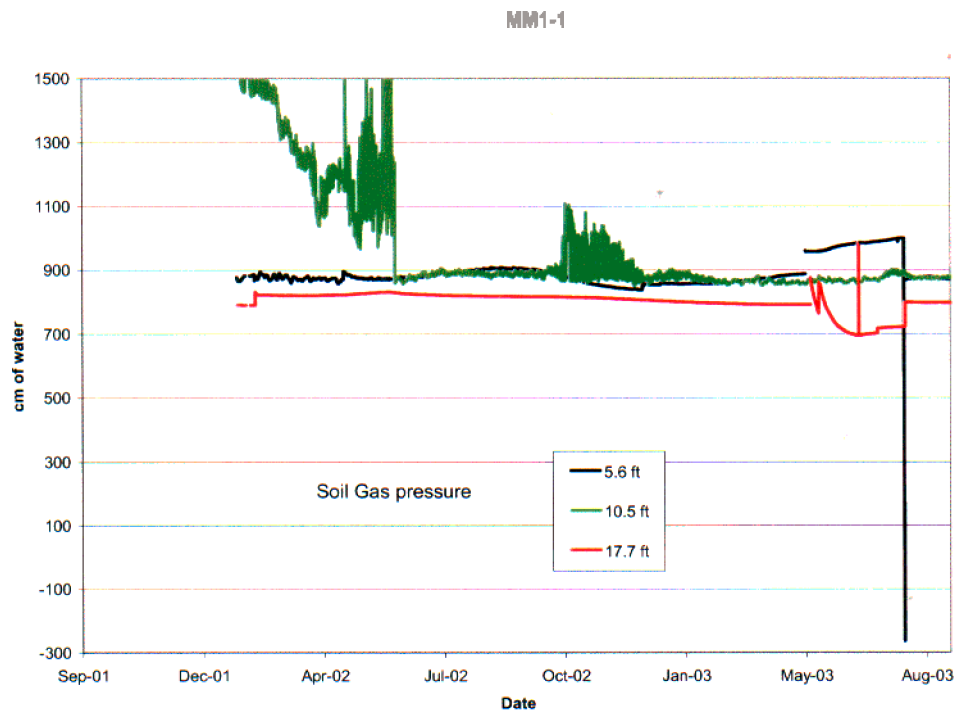
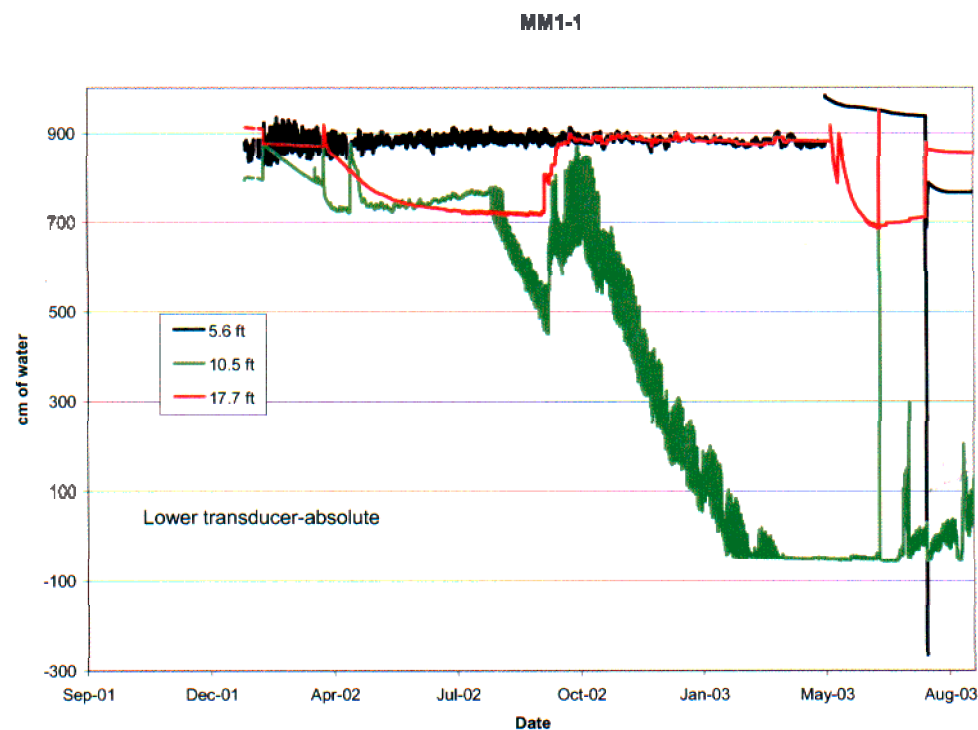
Figure D-10. MM1-1

T1, 5.6 ft: Soil gas pressure works, lower transducer started working July 29, 2003.

T2, 10.5 ft: Soil gas pressure works after mid-2002, lower transducer has failed.

T3, 17.7 ft: Soil gas pressure appears isolated from atmosphere, lower transducer working until July 29, 2003.

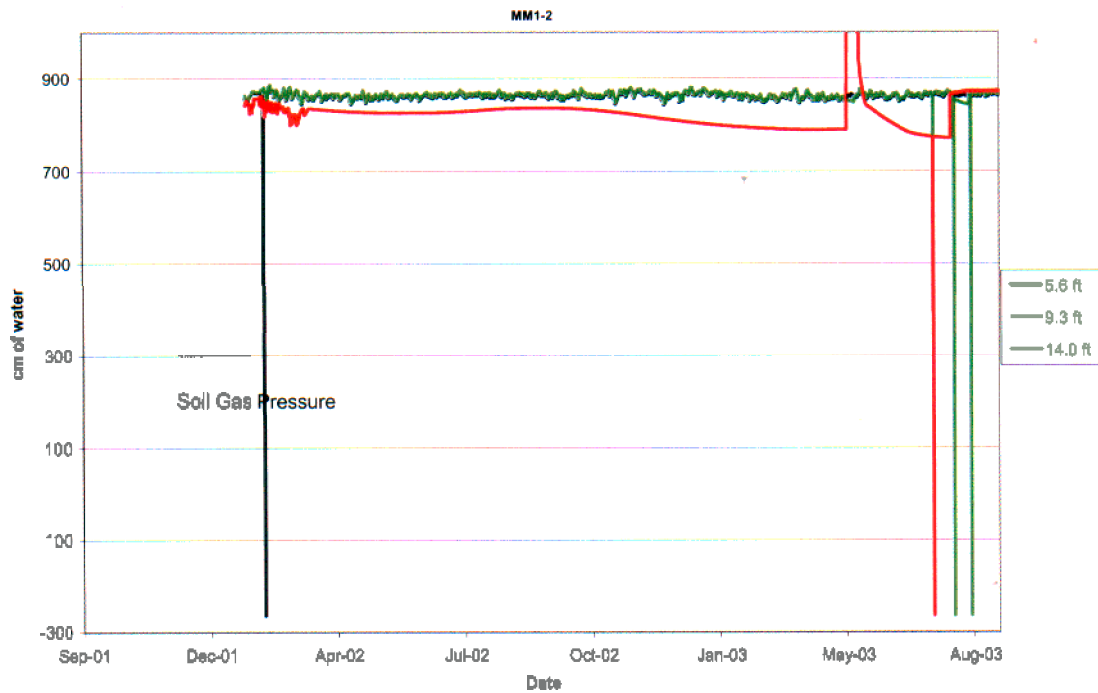
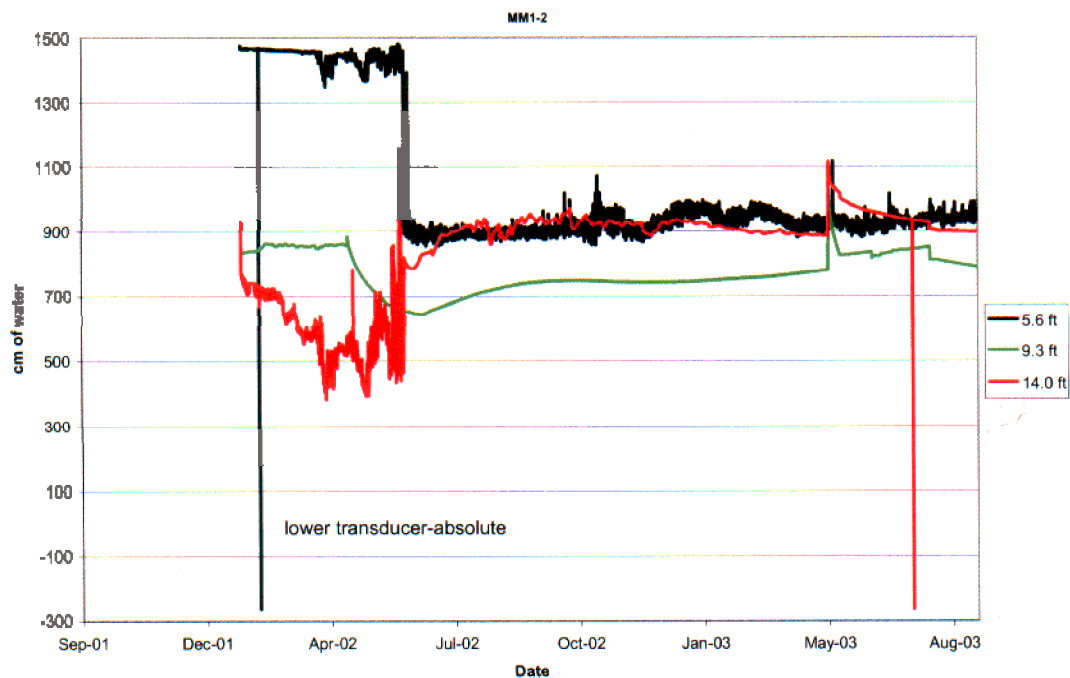
Figure D-11. MM1-2.

T1, 5.6 ft: Soil gas pressure working, lower transducer leaked, couldn't calibrate.

T2, 9.3 ft: Soil gas pressure working, lower transducer worked earlier.

T3, 14 ft: Soil gas pressure isolated from atmosphere but responds to calibration, is questionable, continue to troubleshoot.

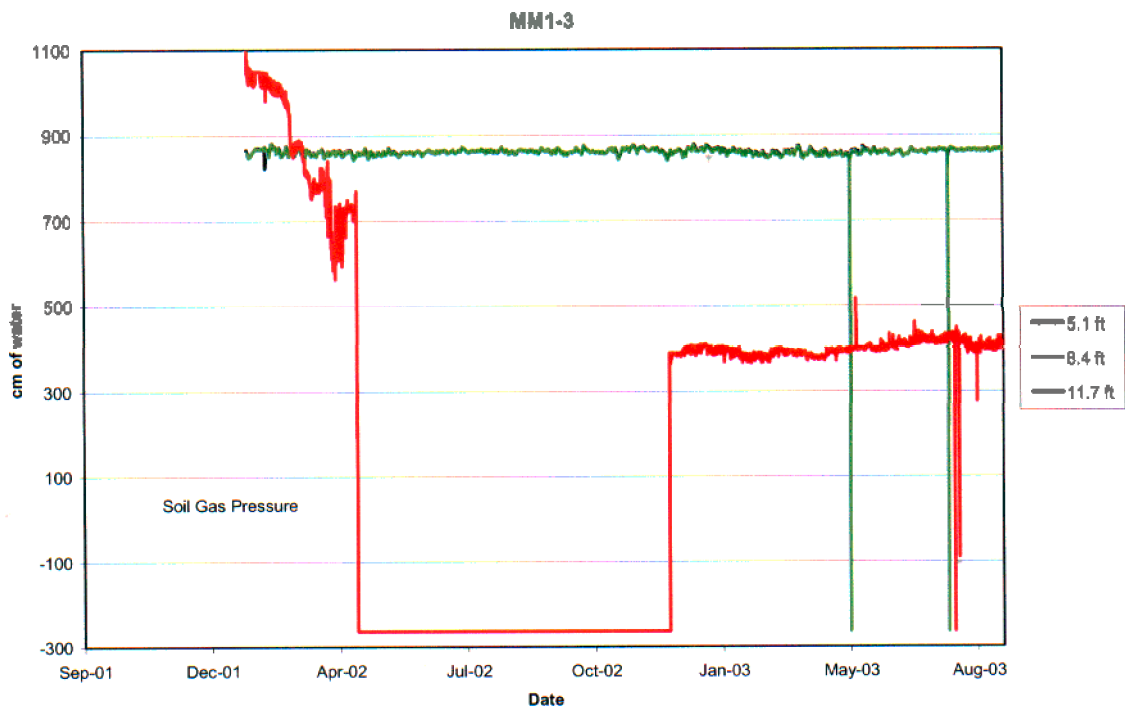
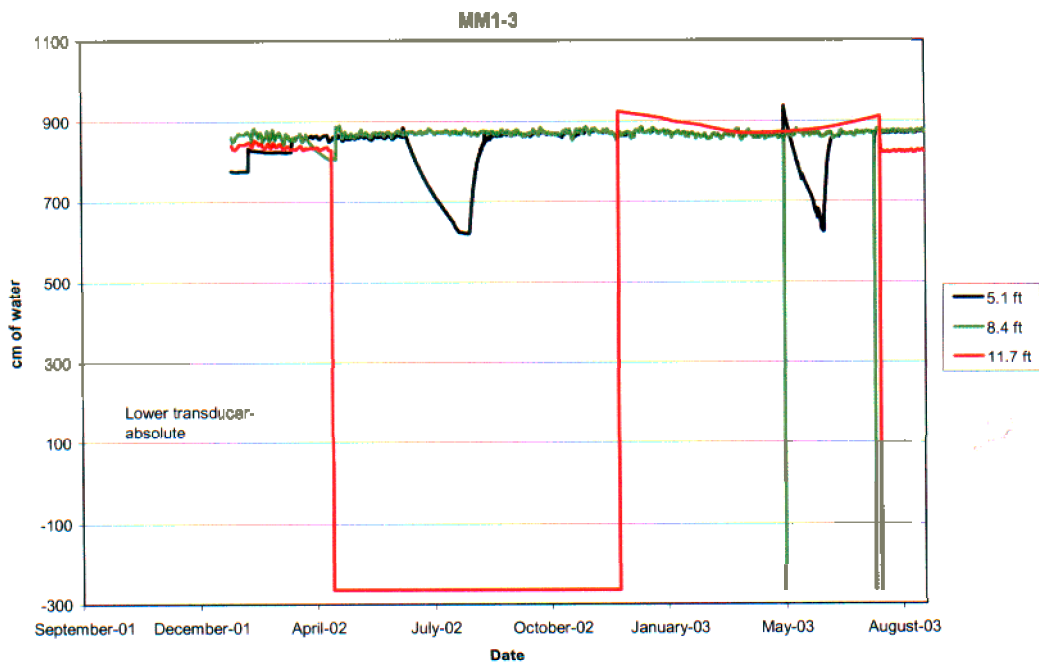
Figure D-12. MM1-3.

T1, 5.1 ft: Soil gas pressure works, solute wp transducer works sporadically.
 T2, 8.4 ft: Soil gas pressure works, solute wp transducer showed early signs of working.
 T3, 11.7 ft: Soil gas pressure and solute wp transducer not working. Water came out of line when applied vacuum to calibrate, so may be saturated.

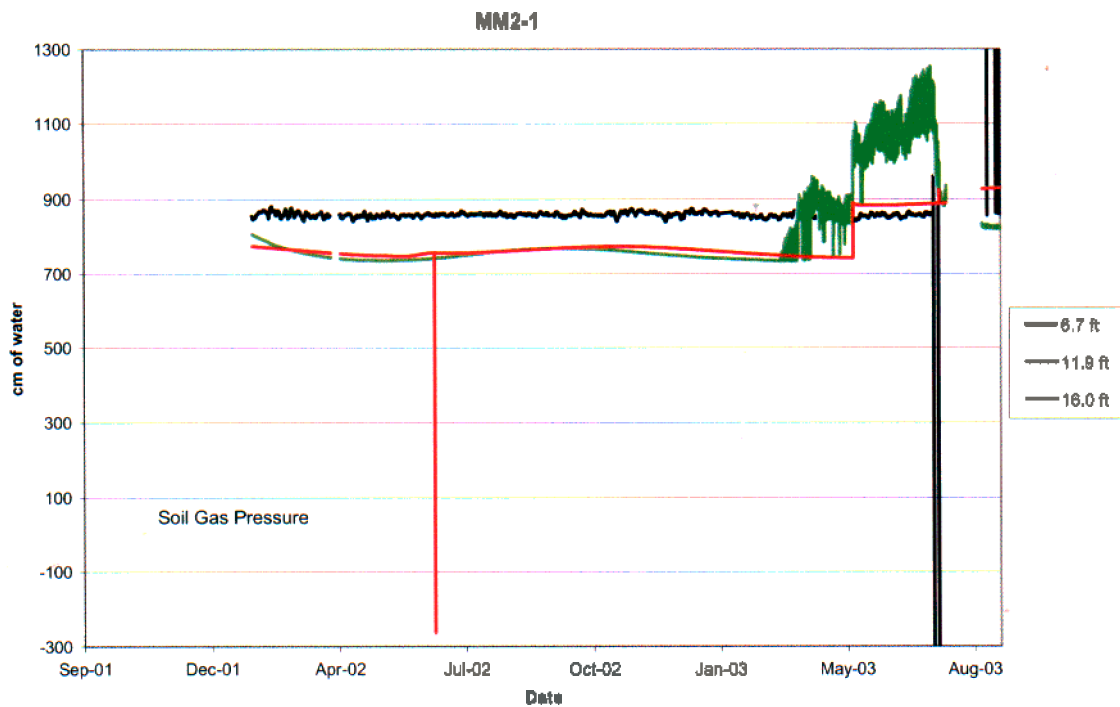
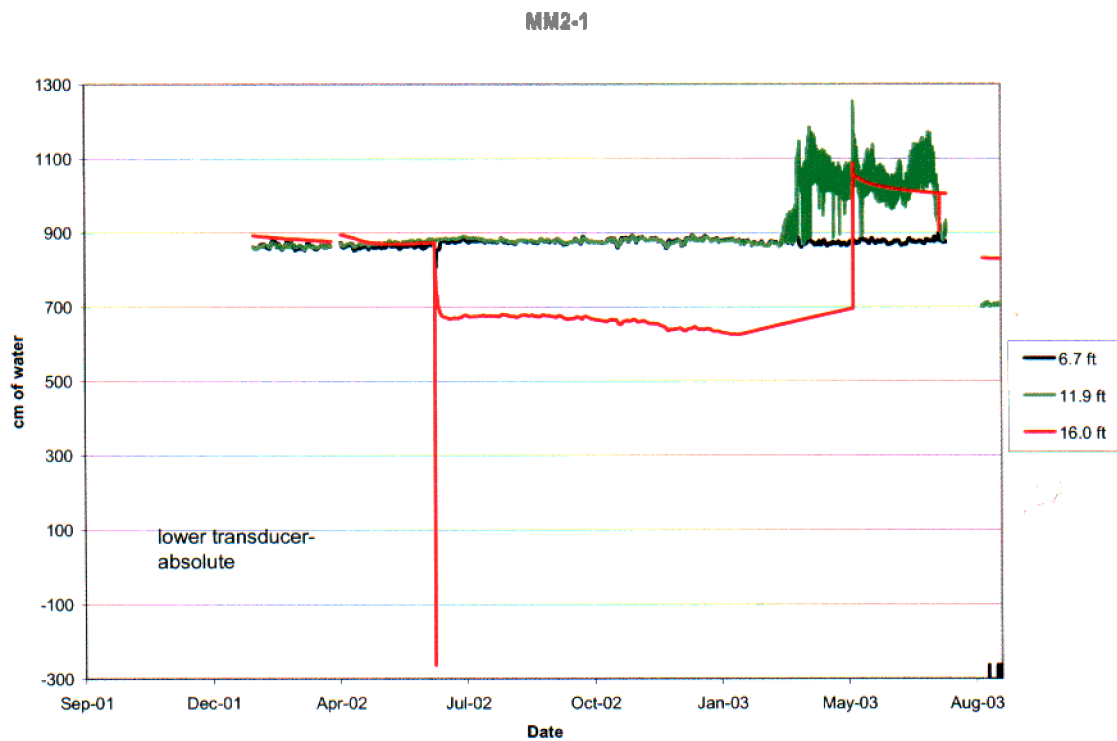
Figure D-13. MM2-1.

T1, 6.7 ft: Soil gas pressure working till fall 2003, absolute wp transducer won't hold vacuum.
 T2, 11.9 ft: Soil gas pressure and absolute wp transducers may be working by fall 2003.
 T3, 16 ft: gas pressure not working in fall, not clear if absolute wp transducer is currently working.

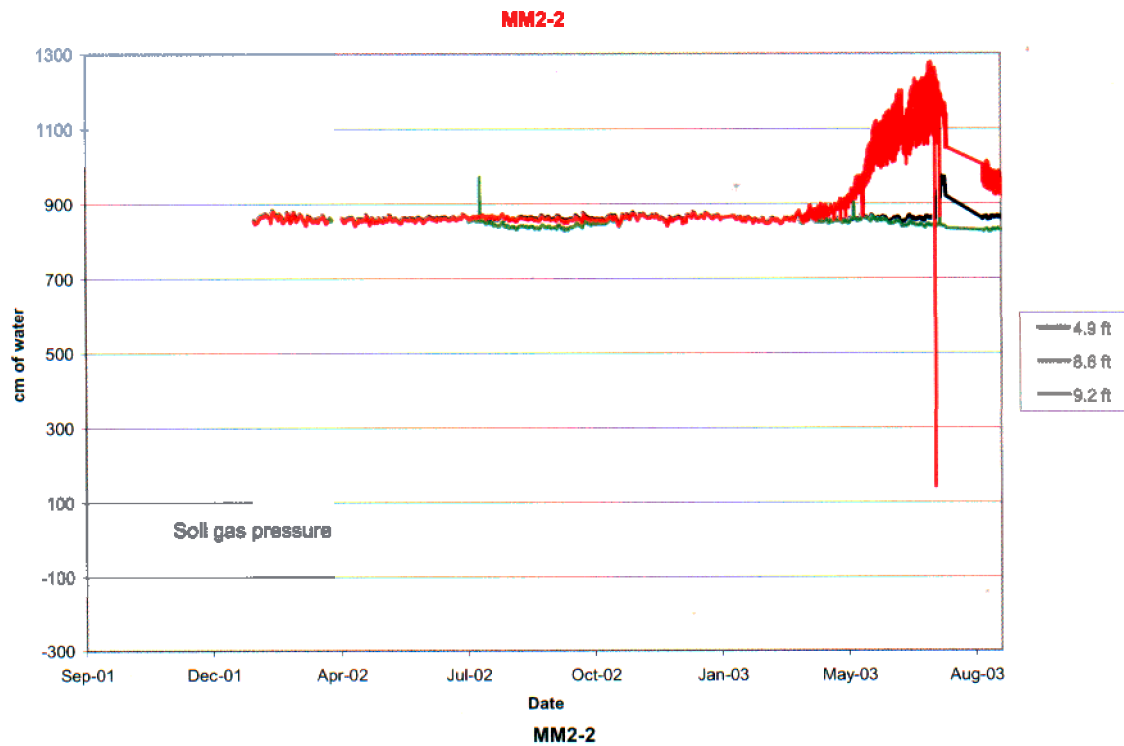
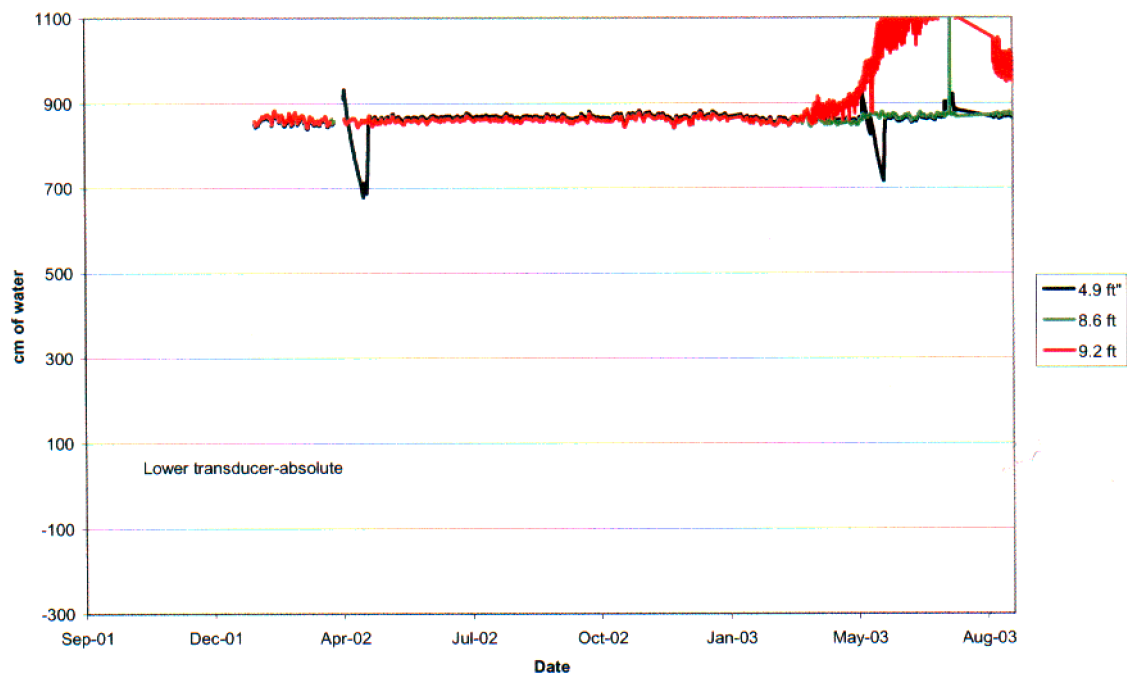
Figure D-14. MM2-2.

T1, 5 ft: Soil gas pressure is tracking well, absolute wp transducer started to work several times.
 T2, 8.6 ft: Soil gas pressure tracks well, absolute wp transducer has shown no signs of working.
 T3, 9.2 ft: Soil gas pressure and absolute wp transducer have electrical problems, lower transducer has shown no sign of working.

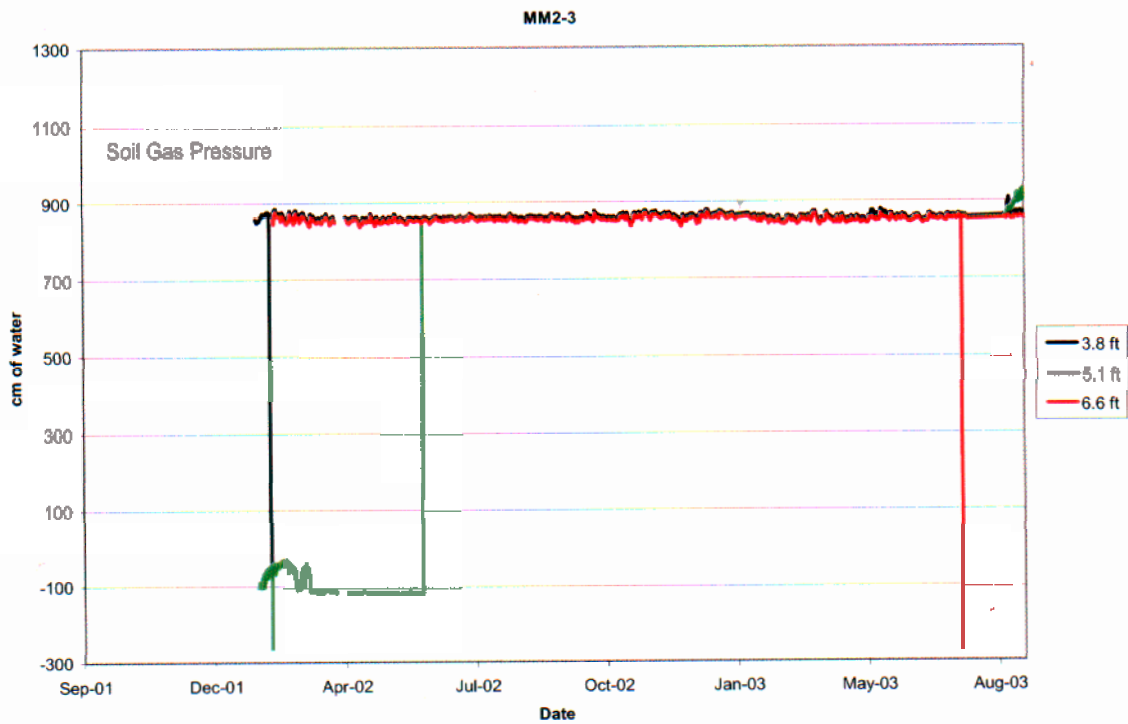
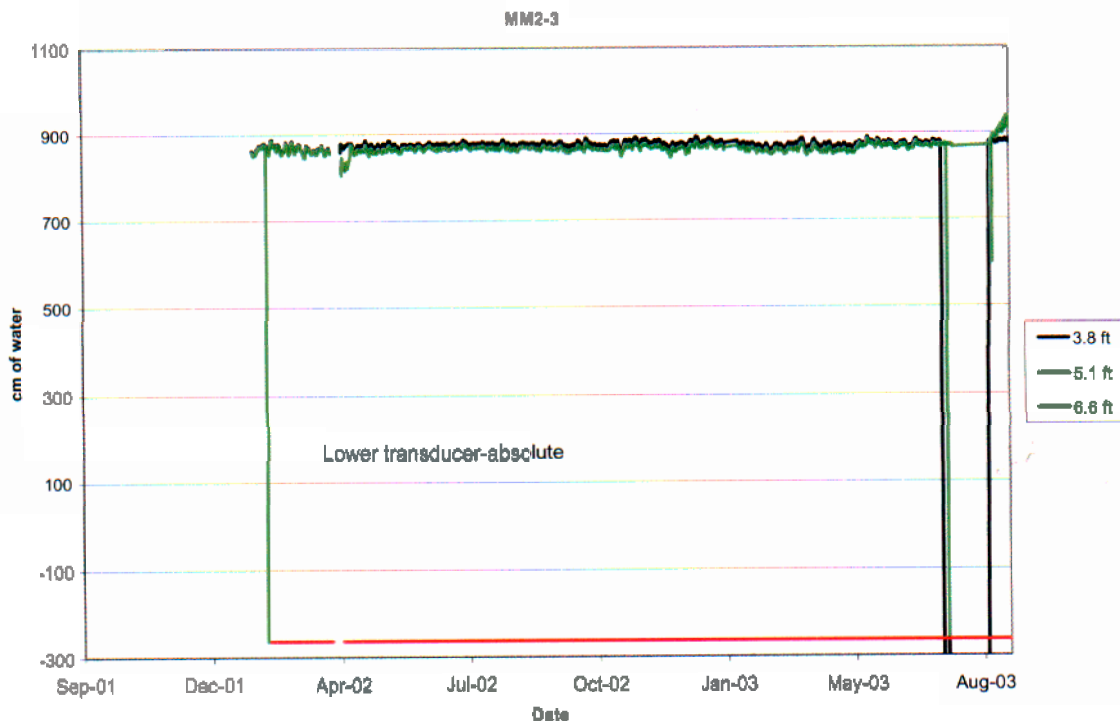
Figure D-15. MM2-3.

T1, 3.8 ft: Soil gas pressure looks good, absolute wp transducer has shown no signs of working.
 T2, 5.1 ft: Soil gas pressure tracks well until August 2003, absolute wp transducer shows no sign of working.
 T3, 6.6 ft: Soil gas pressure tracks well, [REDACTED] has failed.
